## Commissioning of new switchgear

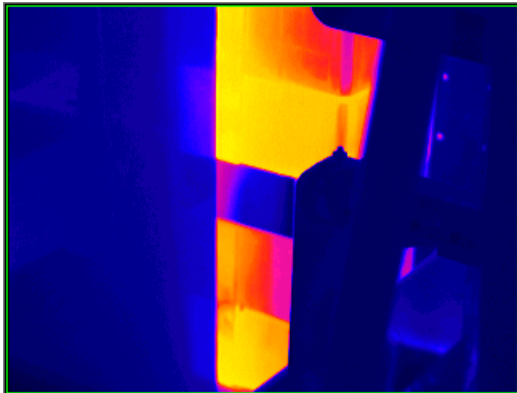
The infrared image to the left is a picture of the bus connection between two main switchgear cabinets. We are looking at this from the back. The cabinet on the left contains the 2,000 amp, 480 volt main breaker. The cabinet to the right, from which we are viewing the connection, houses the feeder breakers. The bus in each cabinet is parallel six inch aluminum. The dog-leg inter-cabinet connections are four 3 inch aluminum sections per phase. What was observed was that two of the phases were hot and the third phase and the neutral were cool. The temperature rise

was 80°F. The load on the switchgear was about half of rated capacity.

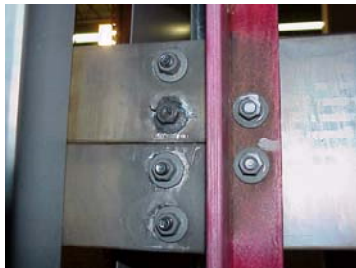
Upon removing the front covers for repair, we discovered that the bolts on the two hot phases were loose. The bolts on the other buses were tight. The picture on the left shows the connection of one of the buses from the front. Note particularly the second bolt down. Because of arcing and heat, the nut had welded to the bolt and the bolt had to be broken to remove it. The bottom picture shows the inside face of one of the dog-leg sections. Note the discoloration around the bolt hole. This is where the dog-leg had welded to the bus. A chisel had to be used to separate the connection. The cost of the repair for these connections was in excess of \$8,000.

We have seen enough of these situations where connections were not properly tightened during installation that we strongly urge industries to have their switchgear commissioned with an infrared inspection before fully accepting it.
